Our Lady of Good Counsel Catholic Church
8601 Wolftrap Rd. SE
Vienna, VA 22182

RE: OLG C – Facade Masonry Investigation
EB#: 2040002.00.V

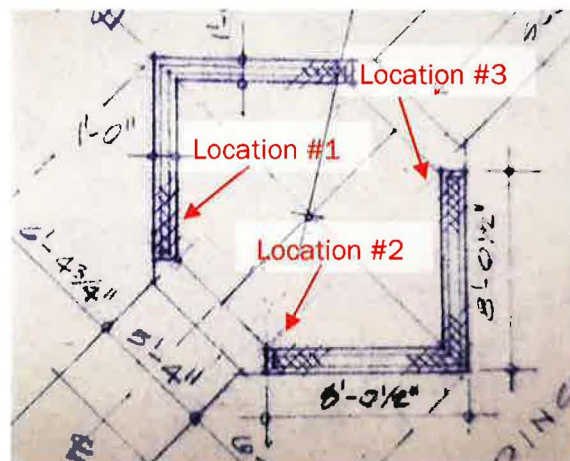
Figure 3 – Intrusive Investigation Locations at the Bell Tower

Full depth cracks through the bricks and mortar joints, approximately 0.007 to 0.06 in width, were observed primarily at the upper parts of the structure in front of the steel columns. Three openings were made to observe the condition of the steel framing behind the brick and find out how the masonry was connected to the steel frame at approximately 15-ft above the ground level.

- Remove and replace a 30" long strip of brick along the steel columns. Install new ties between the CMU and steel columns (which can accommodate movement).
- Provide vertical brick control joints along the columns to allow the brick to move.
- Install adjustable ties between the CMU and new brick.
- Remove and replace deteriorated bricks.
- Repoint deteriorated mortar joints.

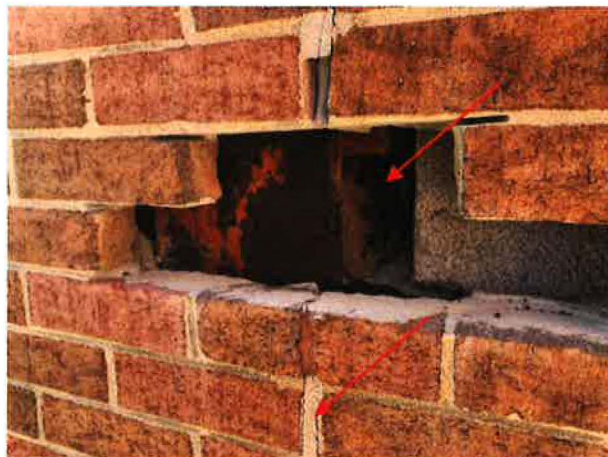
It was then observed that the steel columns were installed tight against the brick without any isolation gap to separate the main framing from the masonry cladding; furthermore, there are no expansion / control joints in the brick masonry to allow its movement. CMU blocks were positioned directly against the flanges of the steel columns (Photograph 1); we also noted that there are haphazardly placed bricks within the column flanges (between the CMU blocks and steel columns). Connection ties between the CMU and the steel columns could not be found at any the three openings.

Photograph 1 – Condition of the Wall at Location 1

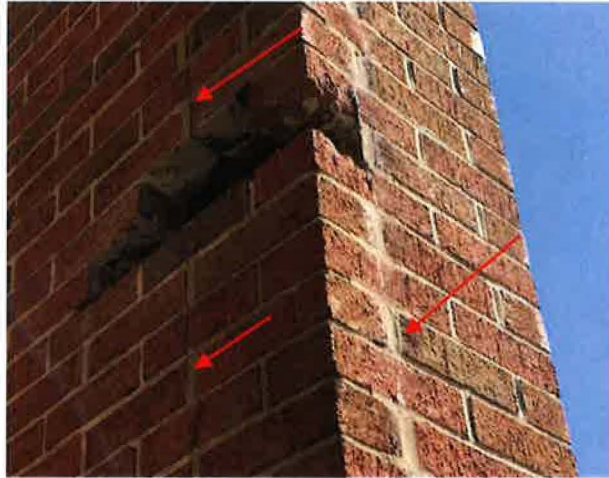
Almost all of the cracks at the bell tower directly align with the column flanges as seen in **Photograph 2** below. Some of the cracks were previously repaired by re-pointing the cracked mortar joints and filling the cracked bricks with mortar.

Photograph 2 – Observed Cracking along a Column

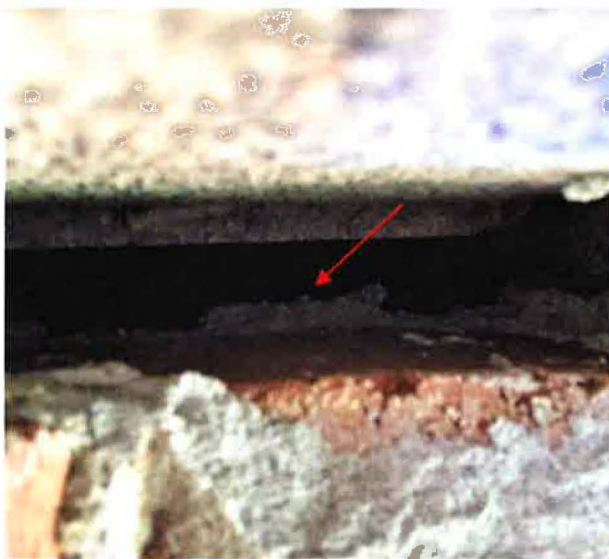
Structural steel framing behind the brick cladding was observed with aid of a borescope camera to identify the degree of corrosion and determine type of the connectors used to tie the masonry to the steel framing. The borescope was extended as much as possible into the wall; however, presence of mortar, blocking the wall cavity, prevented the camera to be extended more than 24". No connectors were noted between the masonry and steel; furthermore, brick ties between the CMU and brick could not be seen. Approximately $\frac{1}{4}$ " to $\frac{3}{4}$ " gap was noted between the brick and CMU (Photograph 3).

Photograph 3 – Gap between the CMU and Brick

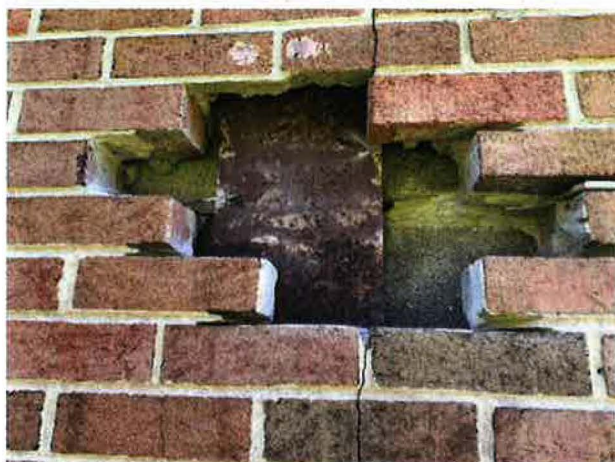
Figure 4 – Exploratory Opening at the West of the Nave (Location 4)

Two intrusive investigation openings were made at the exterior walls at the west and north of the nave where the cracks are reported. Similar to the bell tower, cracks were found to be aligning with the steel columns placed within the exterior walls.

- Provide vertical control joints along the columns.
- Remove and replace deteriorated mortar and bricks.
- Extend the rain leaders further away from the exterior walls.

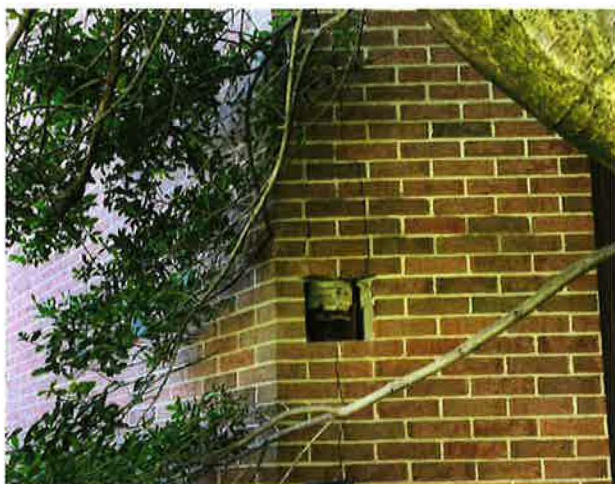
Figure 5 – Explanatory Opening at the West of the Sanctuary (Location 5)

While brick ties were found between the steel column and the brick (Photograph 4), they were not properly welded. As seen in Photograph 5, cracking was more pronounced where the column flanges were perpendicular to the wall. The air gap between the CMU and brick was inconsistent at these two openings, while the bricks were mortared to the CMU at Location 5, there was an approximately 1-inch air gap at Location 6.

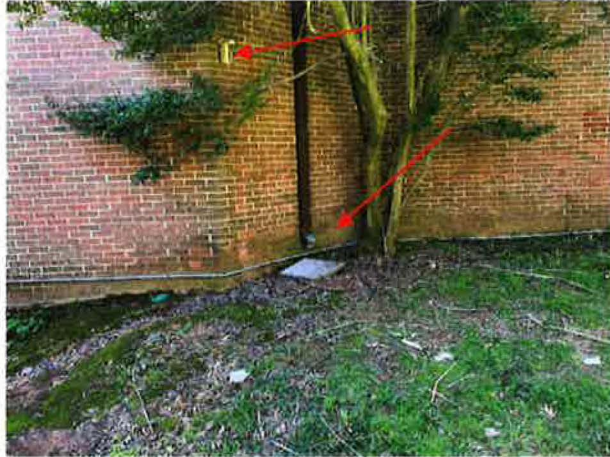
We also noted that the rain leaders were discharging immediately adjacent to these 2 locations where the cracks were investigated (Photograph 4).

Photograph 4 – Rain Leader Next to Location 5
