Our Lady of Good Counsel Catholic Church
8601 Wolftrap Rd. SE
Vienna, VA 22182

RE: OLG C – Facade Masonry Investigation
EB#: 2040002.00.V

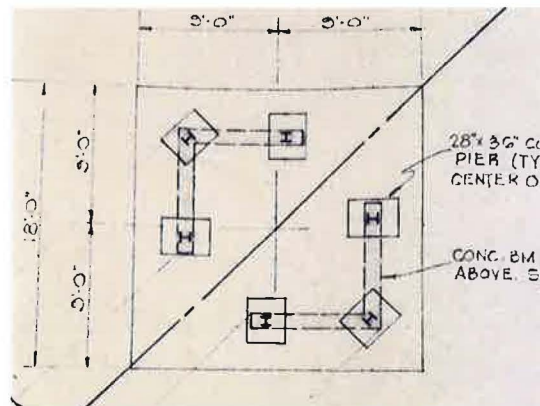
Figure 1 - Bell Tower Foundation

Gravity and lateral load carrying systems of the church building and the bell tower, located at the southeast of the church, consists of steel beams and columns clad with exterior masonry. The approximately 50-ft tall bell tower was constructed with six 8-inch wide steel columns and concrete piers, placed over an 18-ft x 18-ft mat foundation as seen in Figure 1. Existing W8x67 columns and W8x24 beams were constructed as moment frames to resist the wind and earthquake loads acting on the trapezoidal masonry walls. Bases of the steel columns were designed and pins to allow rotation.

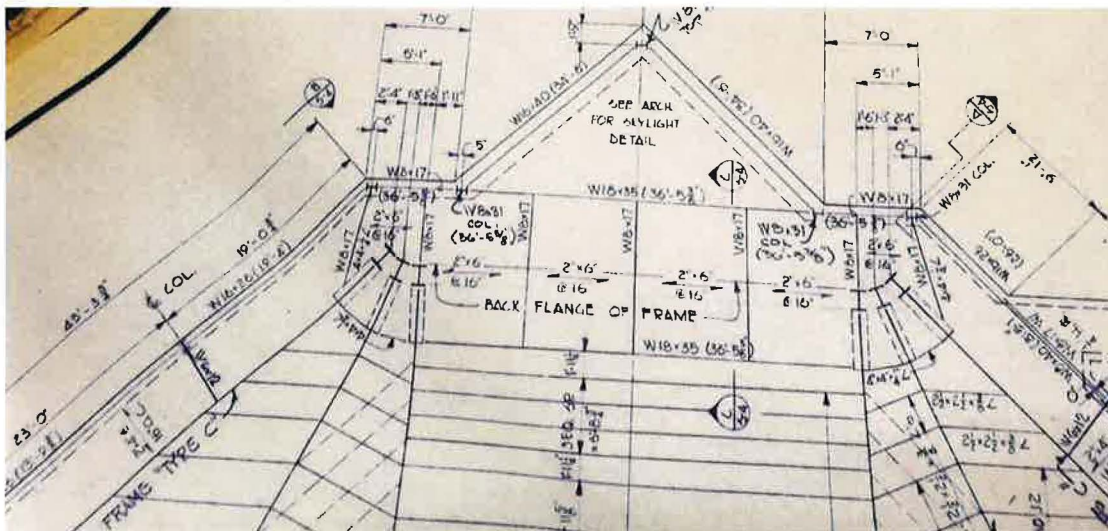
Figure 2 - Main Church Framing

Similar to the bell tower, 1-story church building's framing consists of moment frames, consisting of deep steel columns and tapered steel beams supporting the metal roof diaphragm. 8-inch deep columns were placed within the exterior brick walls support the roof framing at the southeast and northwest of the church structure as seen in Figure 2.

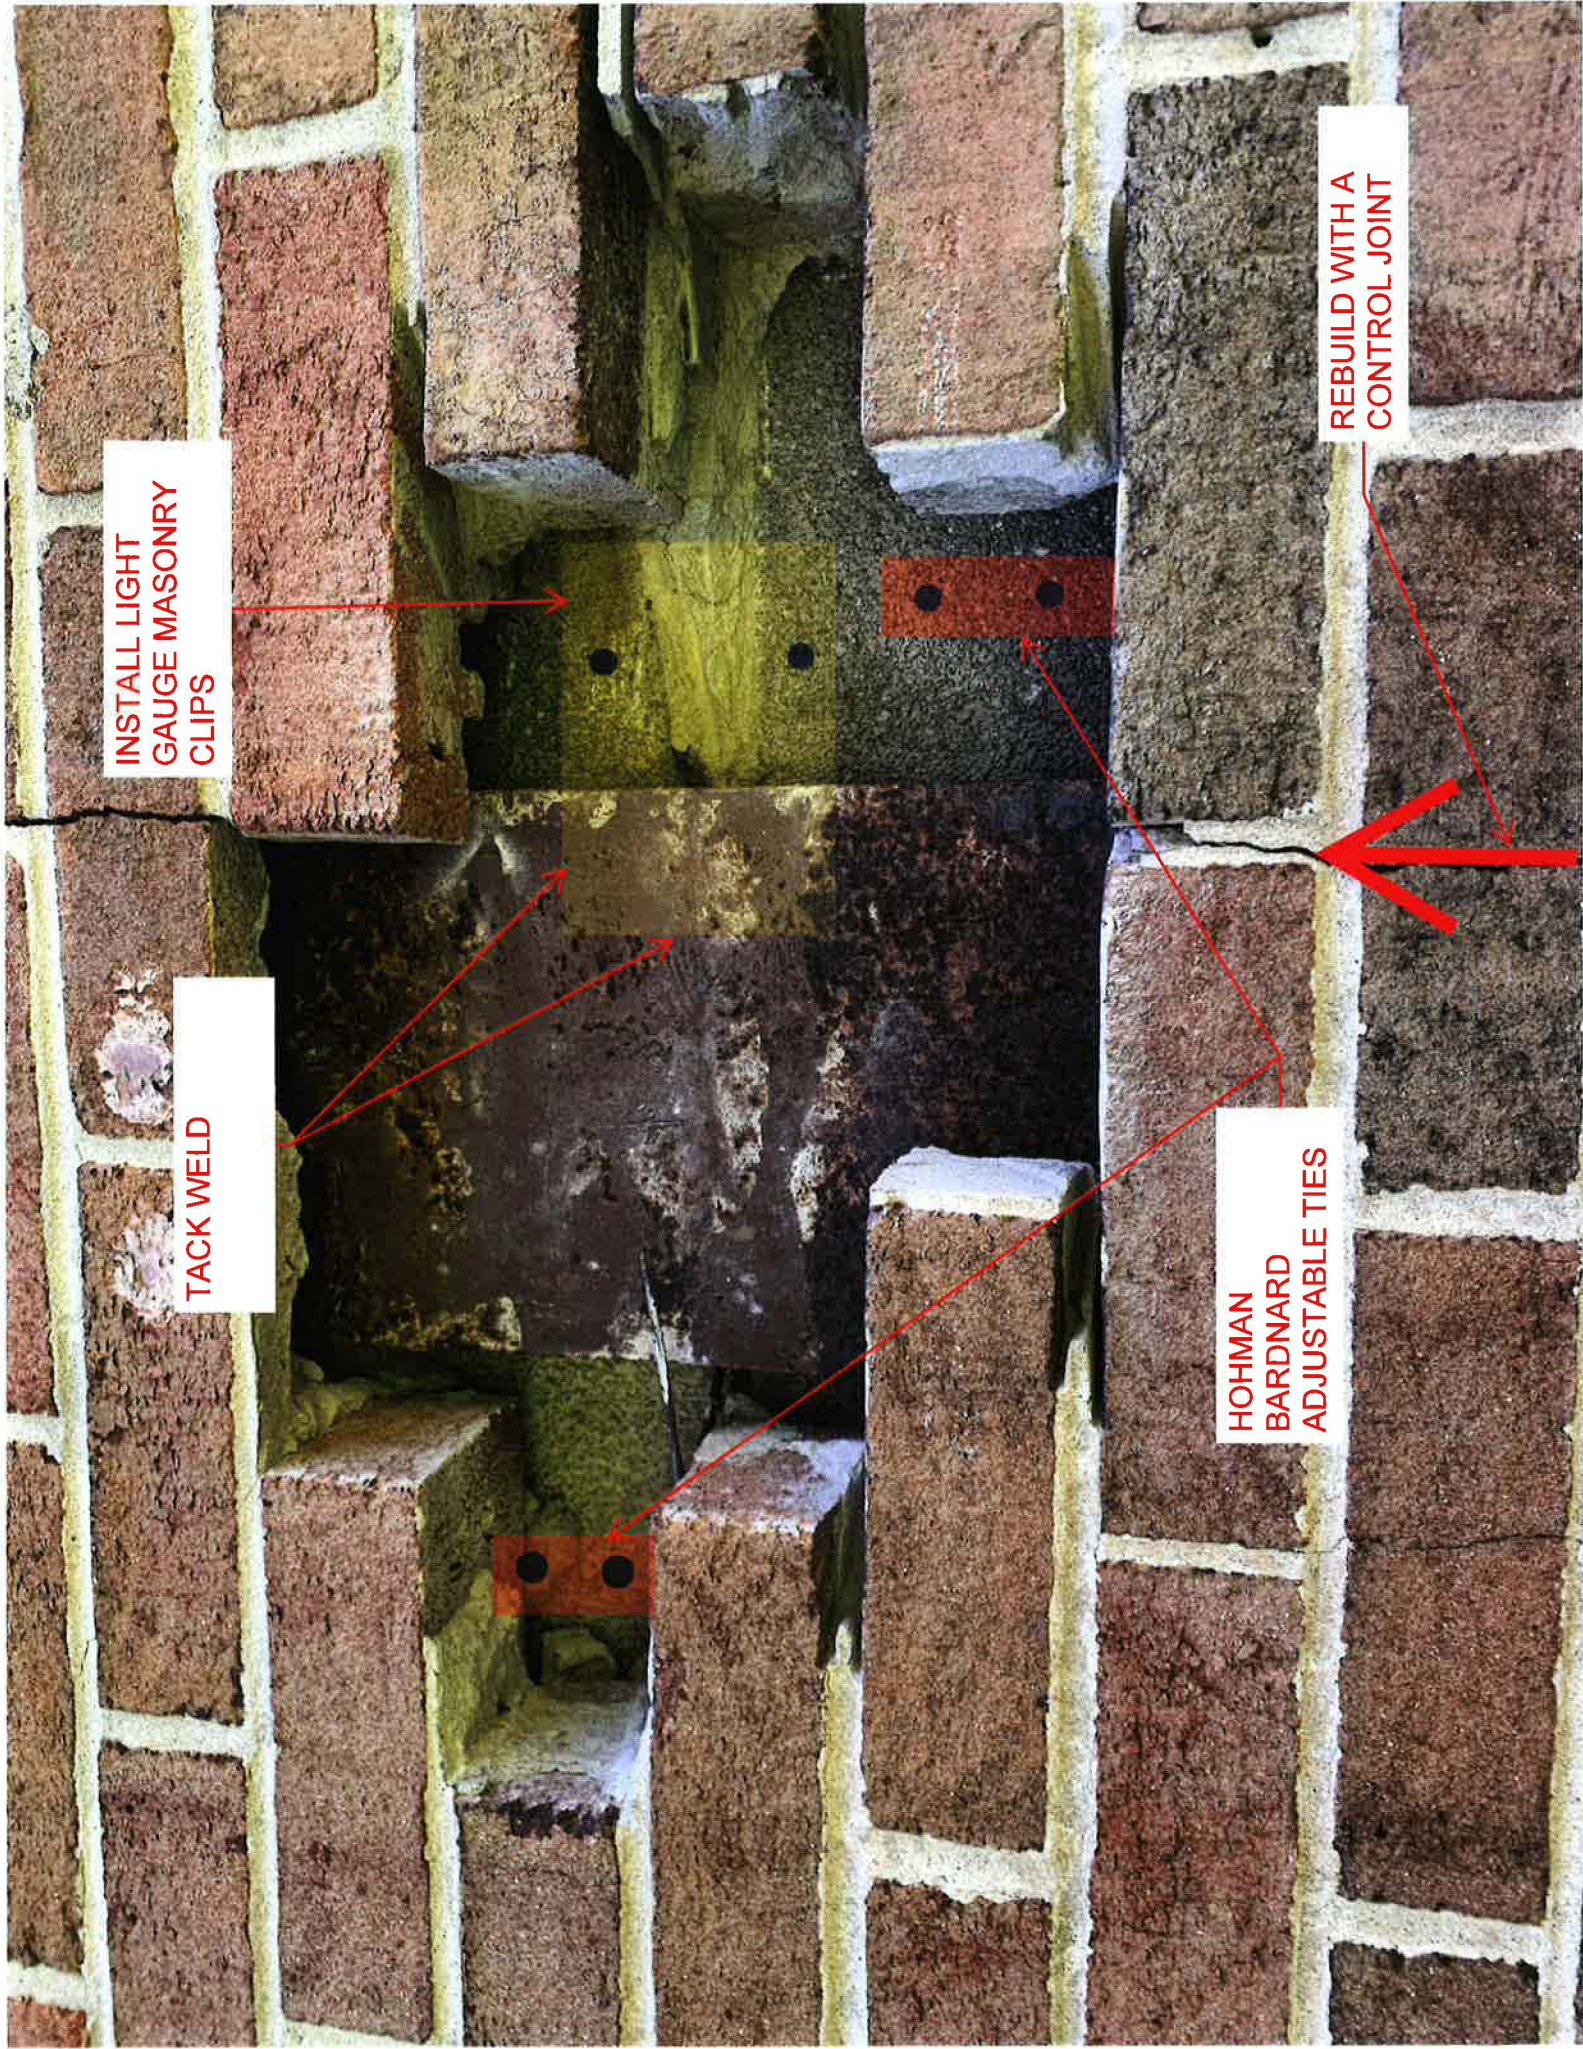
REMOVE AND
REPLACE BRICK IN
FRONT OF THE
COLUMNS

HOHMAN
BARDNARD
ADJUSTABLE TIES

REBUILD WITH A
CONTROL JOINT

- Remove and replace a 30" long strip of brick along the steel columns. Install new ties between the CMU and steel columns (which can accommodate movement).
- Provide vertical brick control joints along the columns to allow the brick to move.
- Install adjustable ties between the CMU and new brick.
- Remove and replace deteriorated bricks.
- Repoint deteriorated mortar joints.
